Project Location and Geology

Geological Profile

Two Borings Performed at Site (B-1 & B-2) and Four Caltrans Borings (08L, 24L, 15R, 19R)

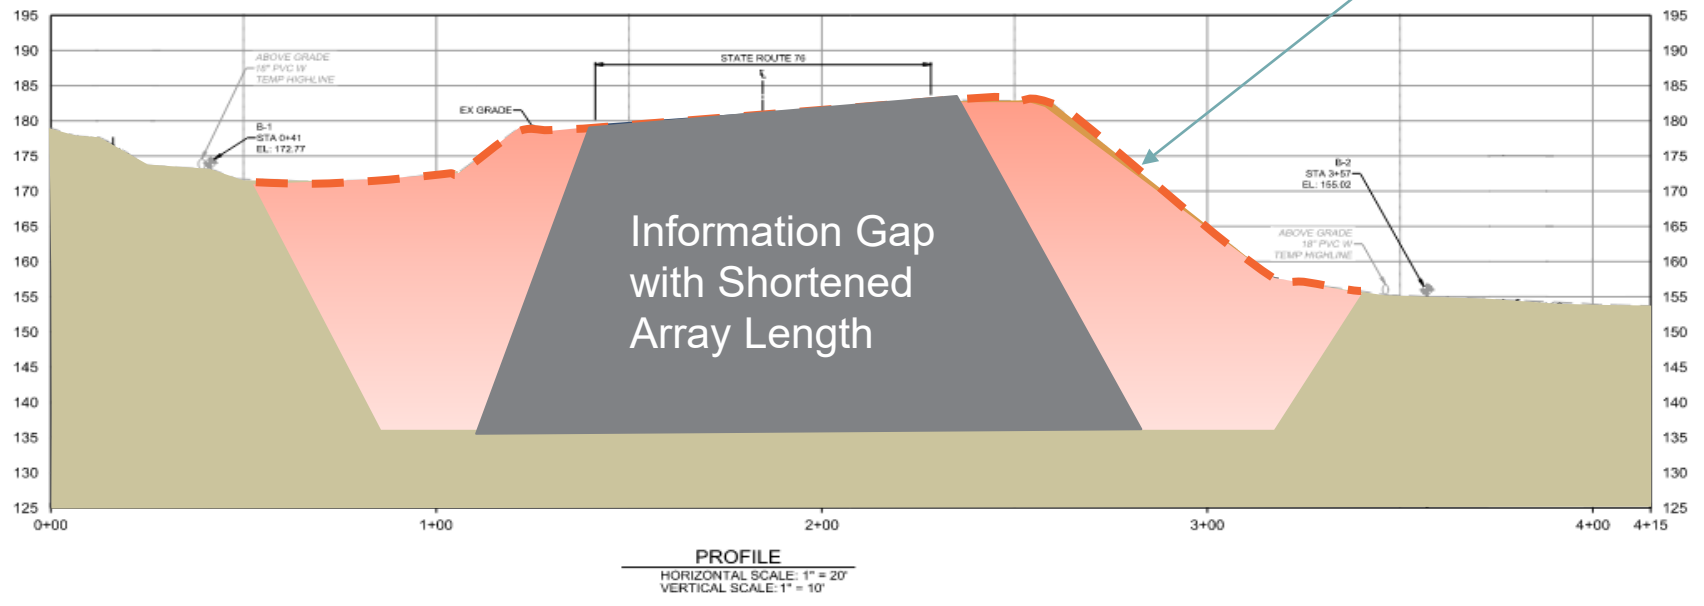
Geophysical Investigation Methods – Array Length

- sensor arrays can be installed in long uninterrupted lengths;
- Ground conditions transition from the surface down in distinct layers from loose to dense (seismic/resistivity shadow zones)
- Area of interest is shallow;
- Area of interest is above the groundwater level.

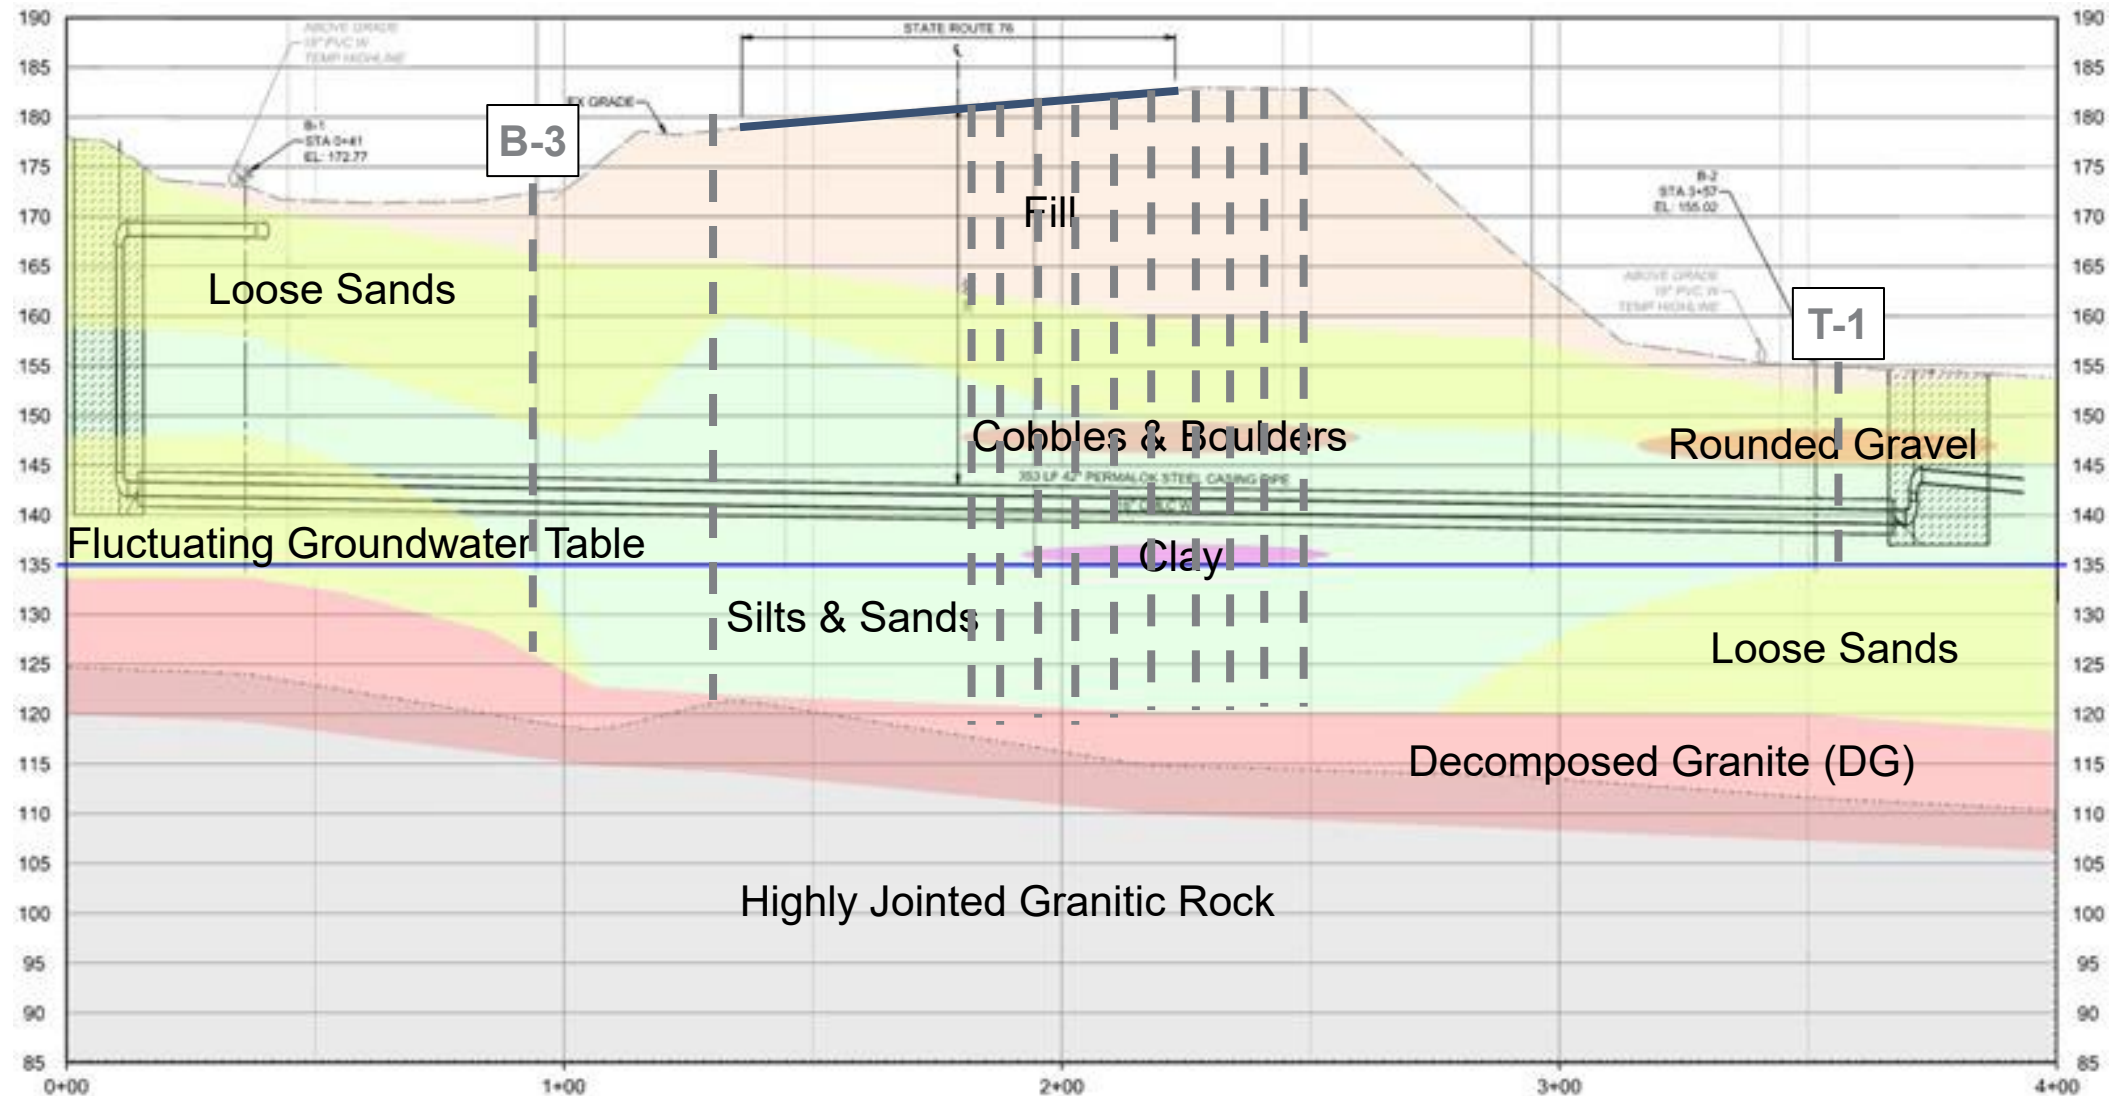
Alternative Investigation Option (Expedited)

Proposed Alternative Investigation which can be performed without Caltrans Permit
