# Pipeline NN Emergency Replacement

BOARD MEETING – GM Comments

July 22, 2025

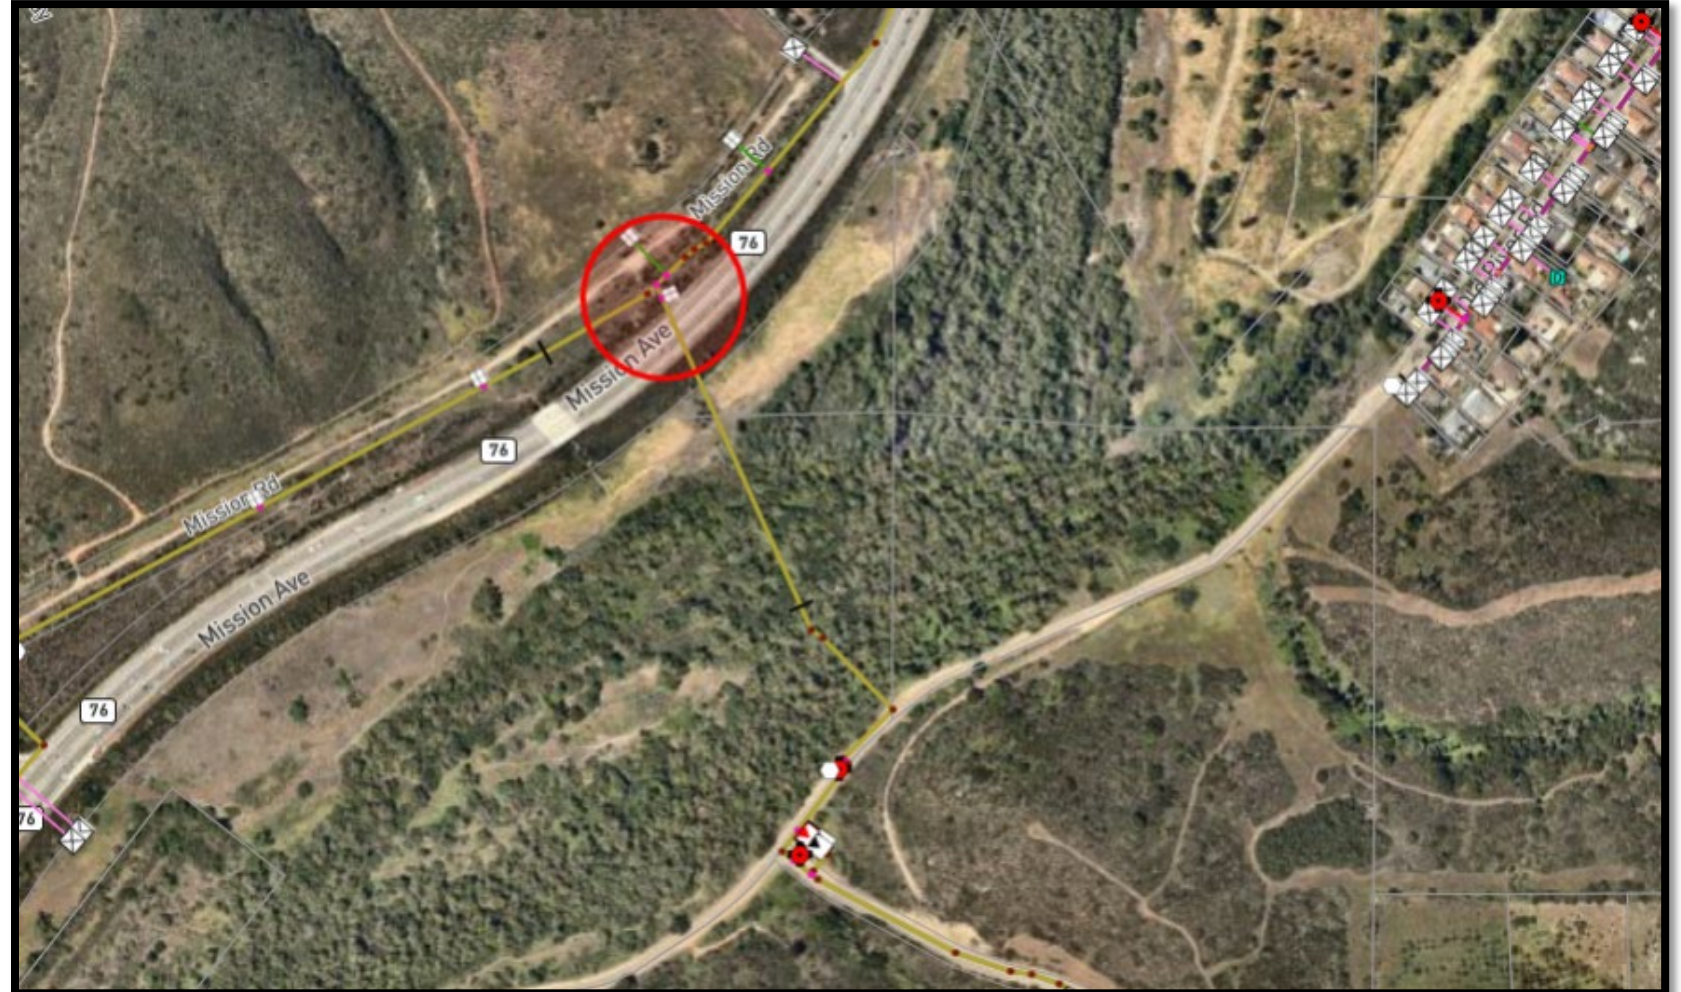
- Main Break in the early hours Wed. June 11, 2025
- 16" Fusible PVC Installed in 2011
- Catastrophic Failure – under investigation as to root cause

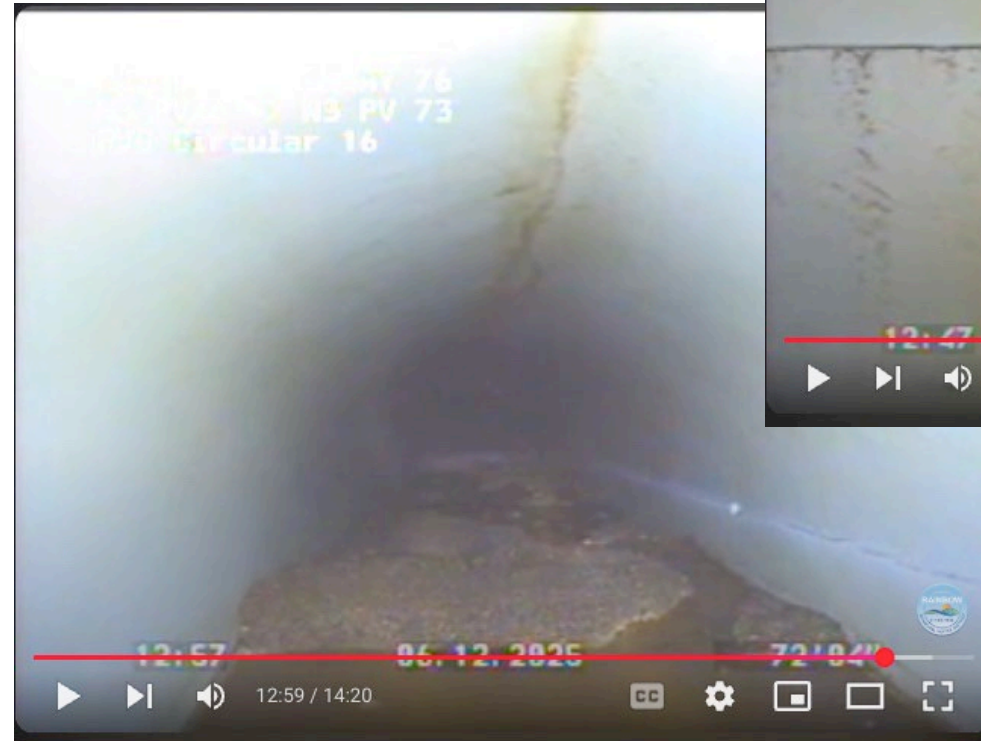
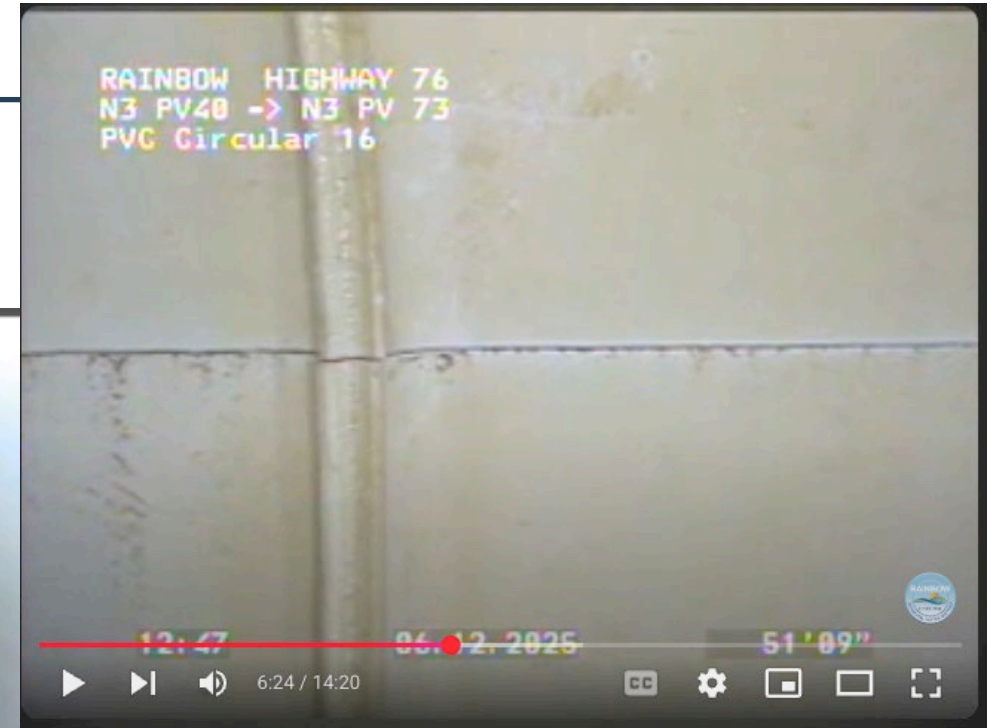
- Damage was assessed via pipe camera
- Split in pipe extends at least 72 feet under Hwy 76

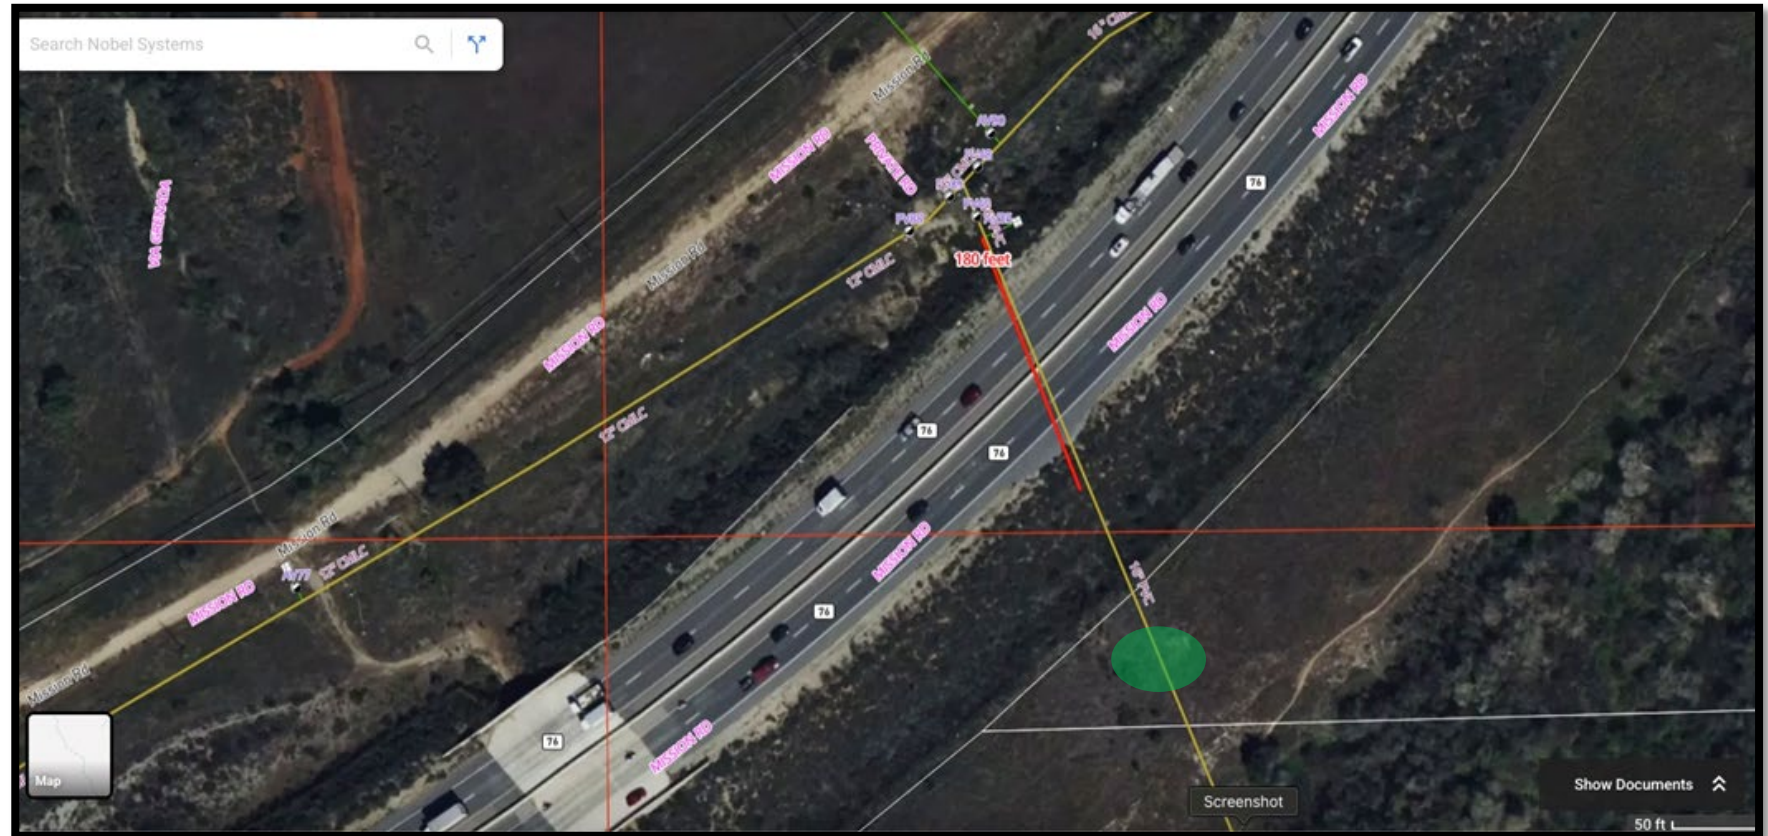
- Assessment indicated No damage to the pipeline south of 76 based
